EXTENSION HILL HEMATITE OPERATION

ANNUAL COMPLIANCE REPORT

Extension Hill Hematite Haulage Road & Rail Siding

2012 – 2013

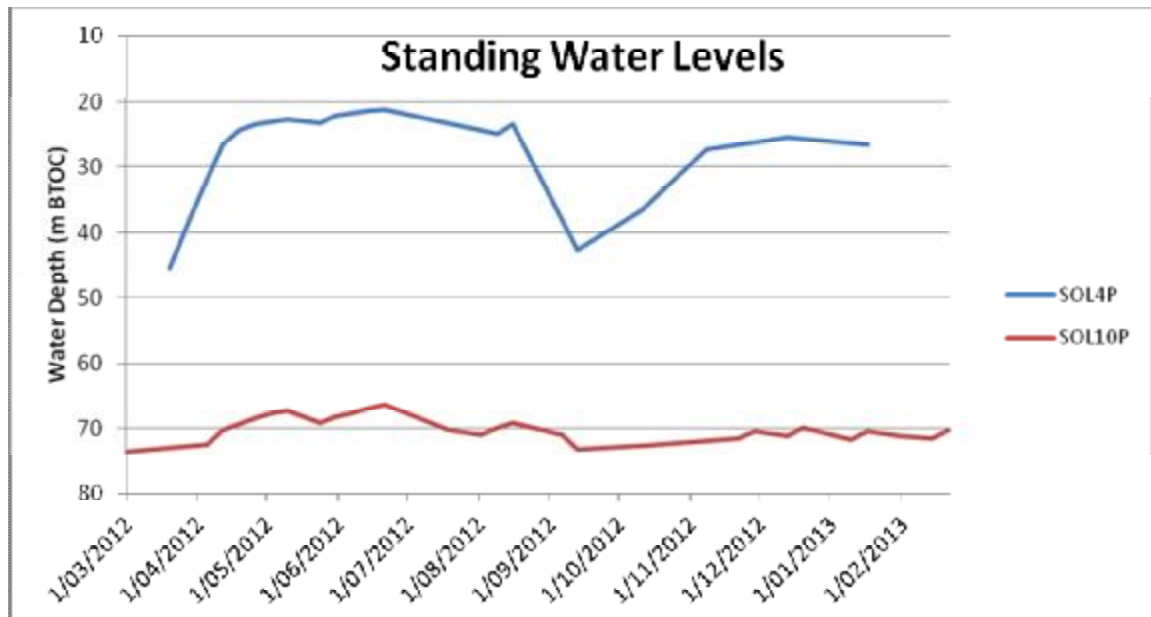
Figure 2 Standing Water Levels

Rockwater (2008) estimated a long-term (6 year) water pumping level of 70m depth (based on 1.2L/s pump rate and assuming that additional aquifer barrier-boundaries are not intersected) for SOL4P and 84m depth (based on a pump rate of 4L/s and assuming that additional aquifer barrier-boundaries are not intersected) for SOL10P. Both bores are carefully managed (including additional monitoring above that required by GWL166651) to ensure sufficient recovery periods to maintain a 24hr standing water level of less than the predicted long-term water pumping levels for both bores (Figure 2).

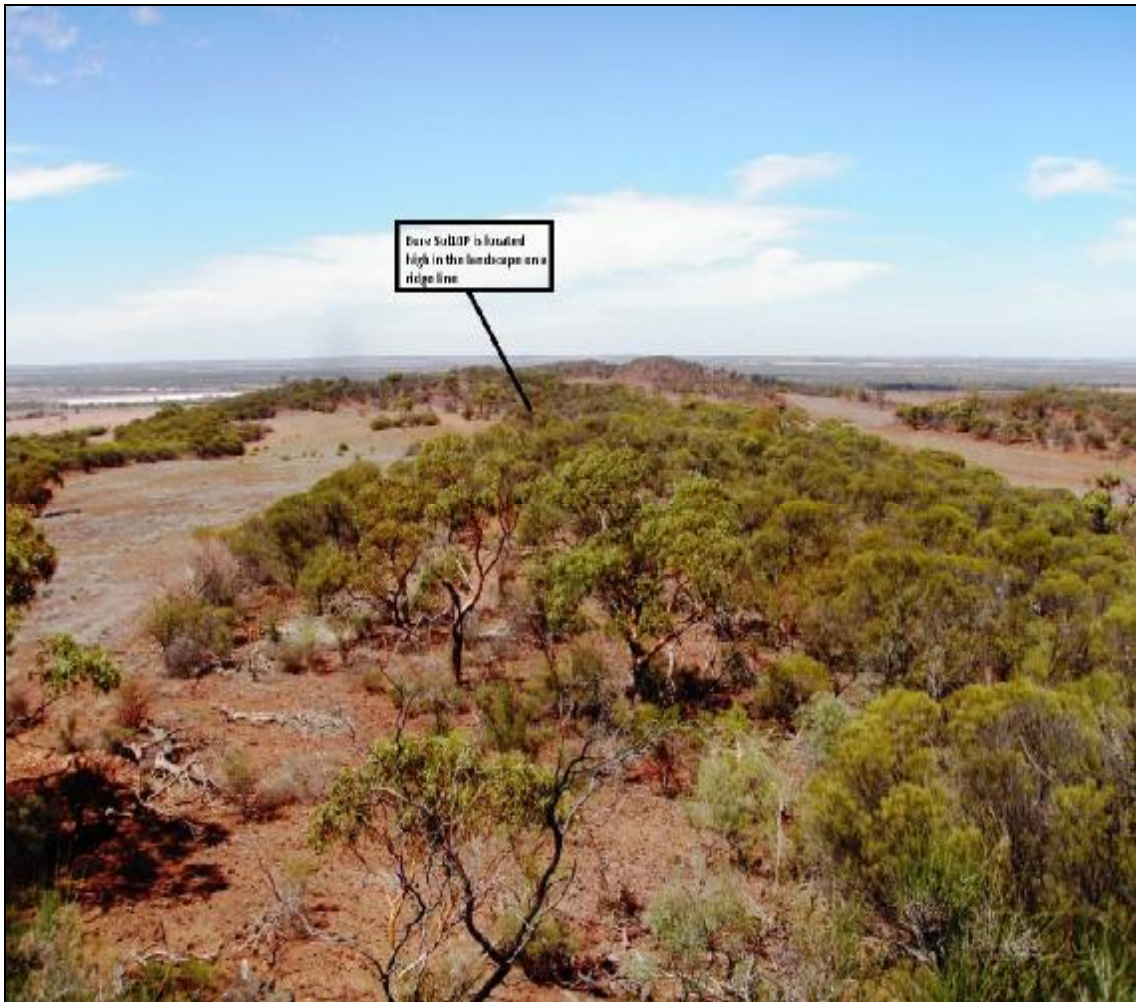
Figure 3 Location of bore SOL10P as seen from rock outcrop 120 metres from bore
Note uniform and dense canopy cover of trees and shrubs along the ridge line. Either side of this vegetation corridor is open pasture.

No negative impacts of groundwater drawdown were observed on the health of surrounding vegetation during or after the initial period of groundwater abstraction at the SOL10P bore. Vegetation health remained unchanged and was similar between plots adjacent to the bore and at a distance of 200m (detailed in the AER for the period 2011 – 2012). In August 2011 pumping from SOL10P recommenced in order to provide water for dust suppression at the rail siding in Perenjori. Since this time vegetation monitoring has consisted of weekly visual inspections coinciding with weekly bore meter reading and water depth monitoring. Up to the end of the current reporting period no observations have been made that would suggest the vegetation in the vicinity of the bore has suffered any ill effects from groundwater abstraction and subsequent draw down of the water table.

SOL10P is located on a ridge line and is significantly higher than adjacent land (Figure 3). The vegetation across and along the ridgeline is dominated by *Allocasuarina sp*, *Acacia sp* and small to medium sized Eucalypt Mallee species, interspersed with occasional larger Salmon Gum (*Eucalyptus salmonophloia*). Understorey and groundcover plants are scarce owing to shading from the canopy and the stony thin skeletal soils of the ridge line. It is concluded that competition from the taller shrub and tree species present effectively reduces the availability of soil water stores to understorey plants. The commonest groundcover species are grass species that are also found in the adjacent pasture.

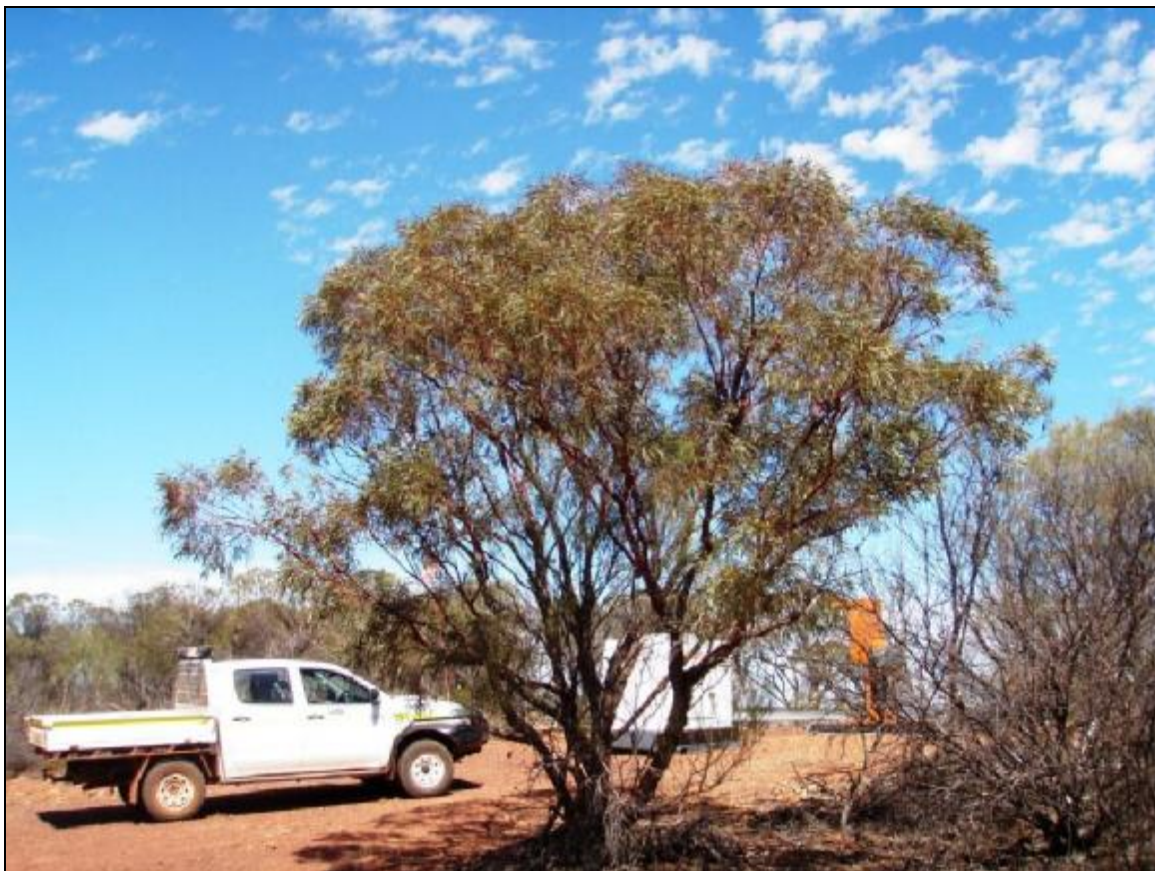
Figure 4 Location of SOL10P

The tree in the foreground is the largest tree in the immediate vicinity of SOL10P. The canopy is full and there are no indications of water deficit distress.

Should pumping at SOL10P continue, it is the intention of MGM to apply to the EPA & DEC to have the condition for monitoring of vegetation health in the area removed from compliance obligations.

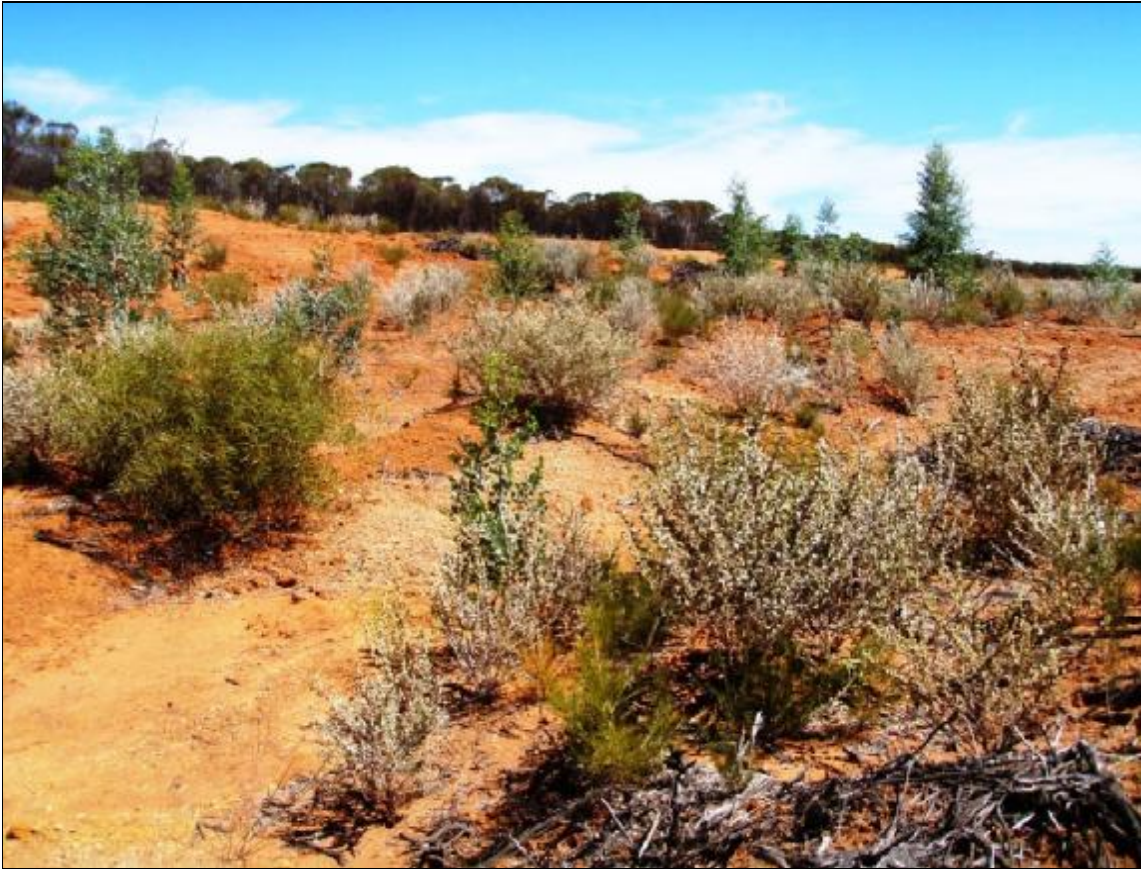
Figure 5 Regrowth at BP27

Figures 5-7 indicate the excellent regrowth at the borrow pits which now includes young Eucalypts in excess of 15ft tall.

This includes over 18 separate species that can be found also growing in the surrounding bushland.

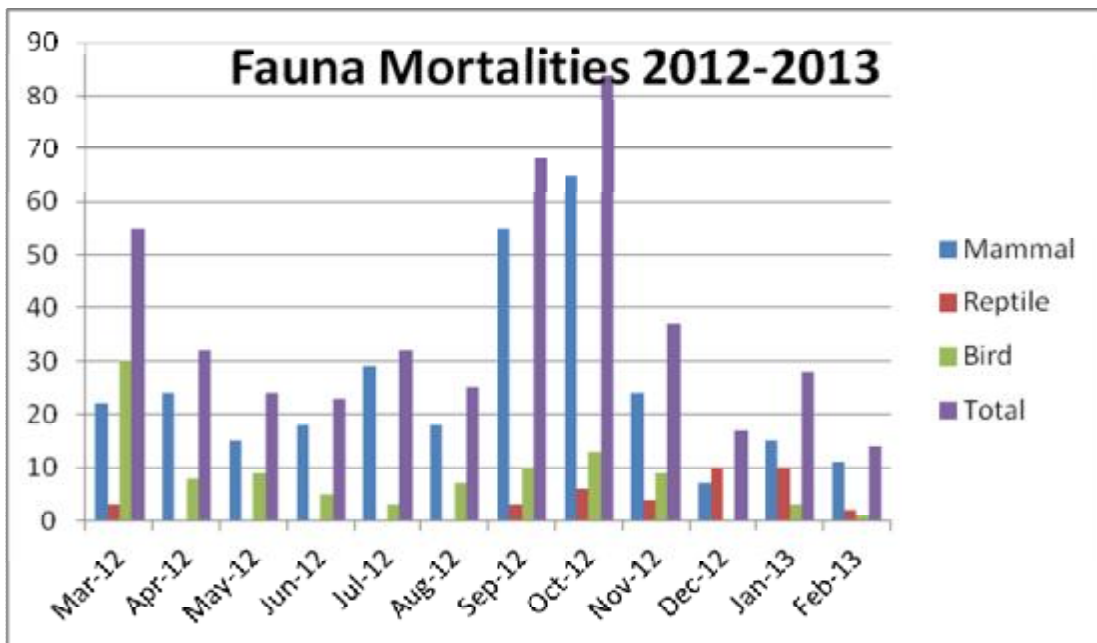
Figure 9 Fauna Road Mortalities by Classification

Two thirds of the animals killed during this period were mammals (Figure 9). Of these the Macropod species (*Macropus rufus*, *Macropus fuliginosus* and *Macropus robustus*) were the most heavily impacted, with a total of 301 deaths recorded in this reporting period. Five introduced species (1 Goat (*Capra aegagrus hircus*) and 4 European Red Foxes (*Vulpes vulpes*)) were reported killed during this period. Galahs (*Cacatua roseicapilla*) were the most common species of bird killed, with 62 deaths recorded, and Goannas (*Varanus sp.*) were the most common reptiles reported killed (23).

Sonic animal repellent devices have been recently fitted to road trains and are currently being trialled. Early results suggest these may be ineffective at reducing Macropod road deaths. The importance of maintaining the speed limit and driving to road conditions is discussed with all personnel during their induction, both for their own safety, safety of public road users and to minimise the potential for impacts on native fauna.

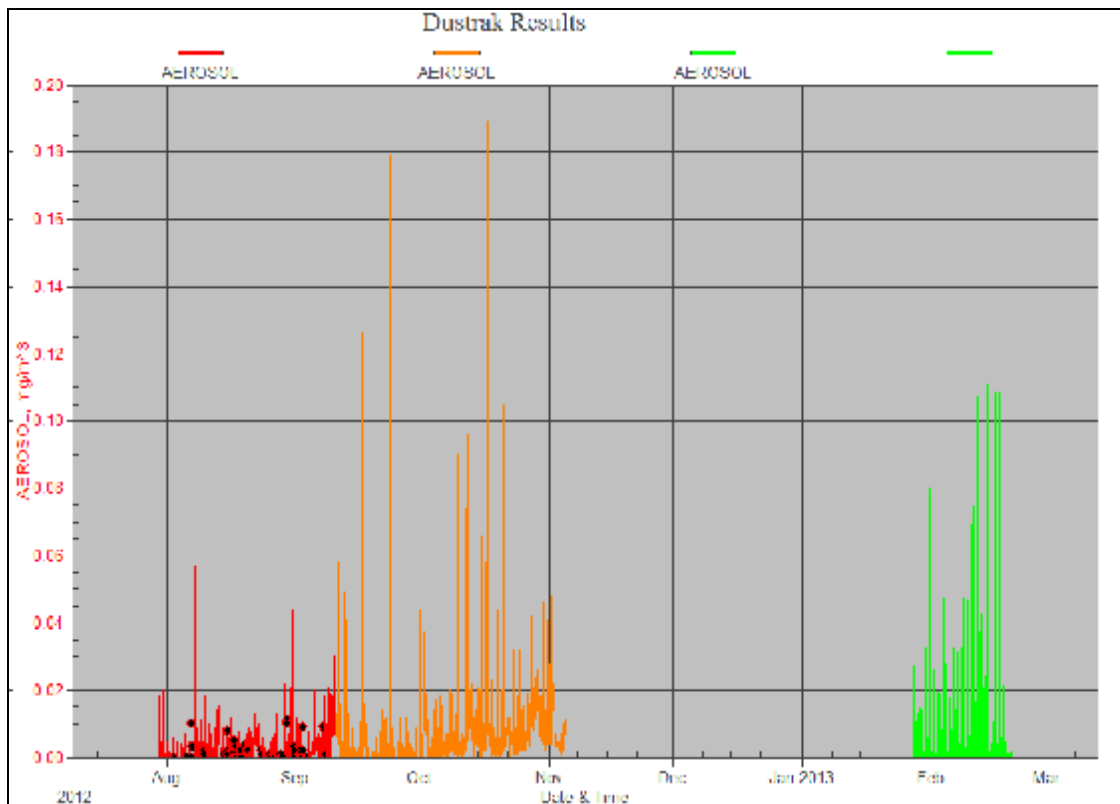
Figure 10 Dust Monitoring Results

There was a high dust event recorded on the 17th of October 2012, with a maximum TSP reading of $370 \mu g/m^3$ (Figure 1). This event lasted less than an hour and the average TSP concentration for the day was $46 \mu g/m^3$. This was the only exceedence recorded during the reporting period.

Due to equipment failures, the Dustrak monitor was out of operation or reporting errors during seven months of the reporting period. Dust monitoring at the rail siding is not required under Ministerial Statement 786, however the Proponent has chosen to conduct this monitoring as an extra precaution. The monitoring program is supplemented by visual observations of site personnel who communicate with water trucks to concentrate water sprays in areas producing more dust, as required. No complaints have been received to date regarding dust emissions from the rail siding facility and the Proponent considers that the current monitoring regime is suitable, despite equipment failures.
