EXTENSION HILL HEMATITE OPERATION

ANNUAL COMPLIANCE REPORT

Extension Hill Hematite Haulage Road & Rail Siding

2012 – 2013

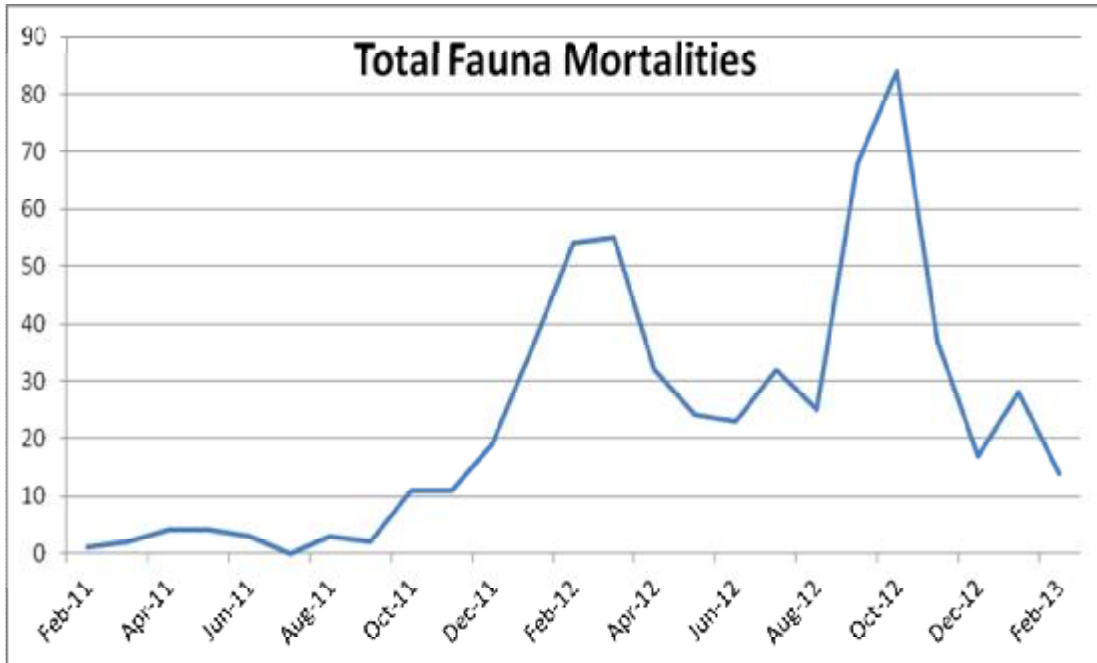
Figure 8 Total Fauna Road Mortalities

However, since monitoring is conducted on a publicly gazetted road not all deaths recorded can be unequivocally attributed to Project related traffic. Nevertheless there has been an increase in the number of fauna road deaths recorded which does coincide with the commencement of road haulage in November 2011 (Figure 8). MGM are actively researching ways to reduce the road death toll, which includes spatial analysis of road deaths, correlation with weather conditions in order to pin point road death patterns and potentially identify hot spots and correlates that can be addressed in the hope of reducing the number of fauna deaths.

Sonic animal repellent devices have been recently fitted to road trains and are currently being trialled. Early results suggest these may be ineffective at reducing Macropod road deaths. The importance of maintaining the speed limit and driving to road conditions is discussed with all personnel during their induction, both for their own safety, safety of public road users and to minimise the potential for impacts on native fauna.
